By Paul Allenstein, PE

Cold-liquid-applied membranes

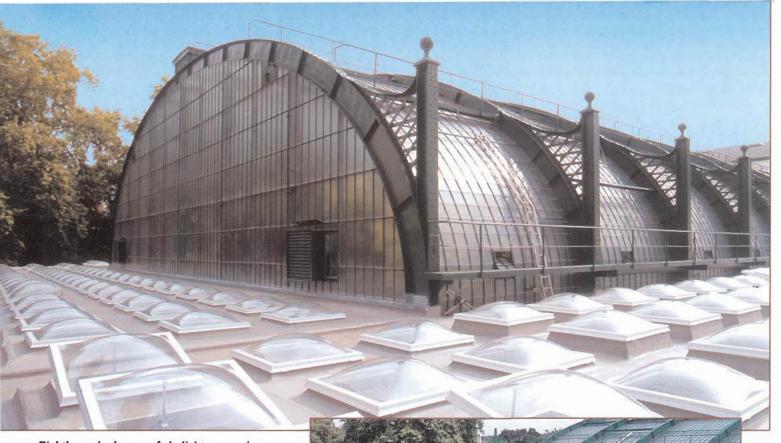
Tightly packed rows of skylights were the weak points of the roof of the Palmengarten in Frankfurt, Germany. In 2000, renovation of the roof was accomplished with coldapplied-liquid membrane. Precut strips of fleece were embedded at the perimeters of the skylights and saturated with liquid polymer resin to form a watertight bond.

During the restructuring of the exhibition halls in the 1980s, the Tropicarium, located at the center of the complex, was extended at the sides by low annexes of the same length. Tightly packed rows of skylights - 169 in all - occupy an area of 11,840 feet, allowing the maximum amount of light to enter the building. These skylights, however, were the weak points of the roof, allowing water ingress over a period of years into the exhibition halls below. The resultant damage restricted the building's use. A roof with so many awkward details in a confined space usually presents a tough challenge for conventional materials, but it was perfect for a liquid-applied system.

flat roof of the annex was completely renovated with a cold-liquid-applied waterproofing and roofing membrane. Where the damage had occurred, the old felt system was removed down to the concrete base. New thermal insulation was laid, and the surface and details then treated with epoxybased primer to ensure bonding to the base surface.

The cold-liquid-applied waterproofing and roofing membrane, based on unsaturated polyester resin reinforced with polyester fleece and with excellent vapor permeability, was applied to an average dry-film thickness of 2 millimeters. Each of the 169 skylights, arranged in three rows at regular intervals, received waterproofing around its perimeter. To achieve this, a layer of the

membrane was applied to the primed curb, and precut strips of fleece were bedded in and thoroughly saturated with the liquid polymer resin.

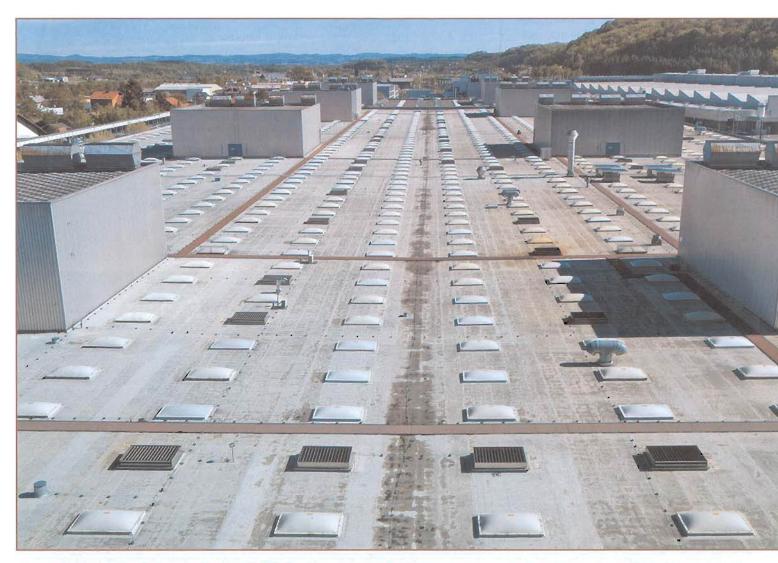
Some 646,000 square feet of liquid waterproofing have been laid over the various roof components on the BMW plant roof in Steyr, Austria, over the last 15 years.

All details, junctions, joints, and upstands on BMW's roofs were water-proofed with a seamless membrane spread

over the surface and reinforced with a fleece inlay. Once it has cured in situ, the material forms a permanently resilient, seamless waterproofing layer that fits the intricacies of the existing structure like a tailor-made glove fully bonded to the substrate. As a rule, waterproofing and roofing systems can be applied to existing roof finishes without removing them first and thus incurring additional costs.

The synthetic material is tear-resistant and bridges over cracks up to 2 millimeters wide. It also remains permanently resilient and flexible over a temperature range of -30°C to +90°C. Therefore, this waterproofing system is able to accommodate structural movements and the different thermal movements of various building materials without damage.

Some 646,000 square feet of this liquid waterproofing system have been laid in Steyr over a period of 15 years. Extensions and rebuilding work continue at this plant,

and on the roofs there are always individual components or even complete rooftop structures to be added or removed. The roofing contractor, therefore, welcomes the ease with which new sections of waterproofing can be easily joined to existing areas. Cold-liquid-applied systems bond fully to themselves and the use of a homogeneous waterproofing system preserves the appearance of the buildings.

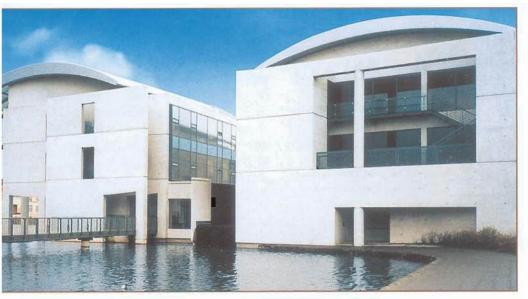
The Reykjavik City Hall in Iceland's Faxa Bay has two levels of parking below water level, and its upper stories are surrounded by water. All areas were waterproofed with cold-liquid-applied monolithic waterproofing and roofing membrane.

Due to the location of the building in the harbor basin (two levels of its underground car park actually extend below the water level, and both upper parts of the building

are surrounded by water), the demands placed on the waterproofing of the building were unusually high.

Complete waterproofing of the city hall and the underground car park against the surrounding water, using a cold-liquidapplied, monolithic waterproofing and roofing membrane, allowed exterior water-carrying structures to perform at peak levels while keeping the interior dry and well protected.

All watercourses were completely waterproofed, as were the building's walls and roof. This included all drainage channels, passages around the building that were below sea level, plaster on the seals, façade panels, expansion joint covers, window connections and entrance steps, roof surfaces without drainage, water cascades on the outer facade, and concrete pillars projecting out of the water.
