## Kemperol Cures Roof Ailments at Poole Hospital

Poole Hospital, Dorset

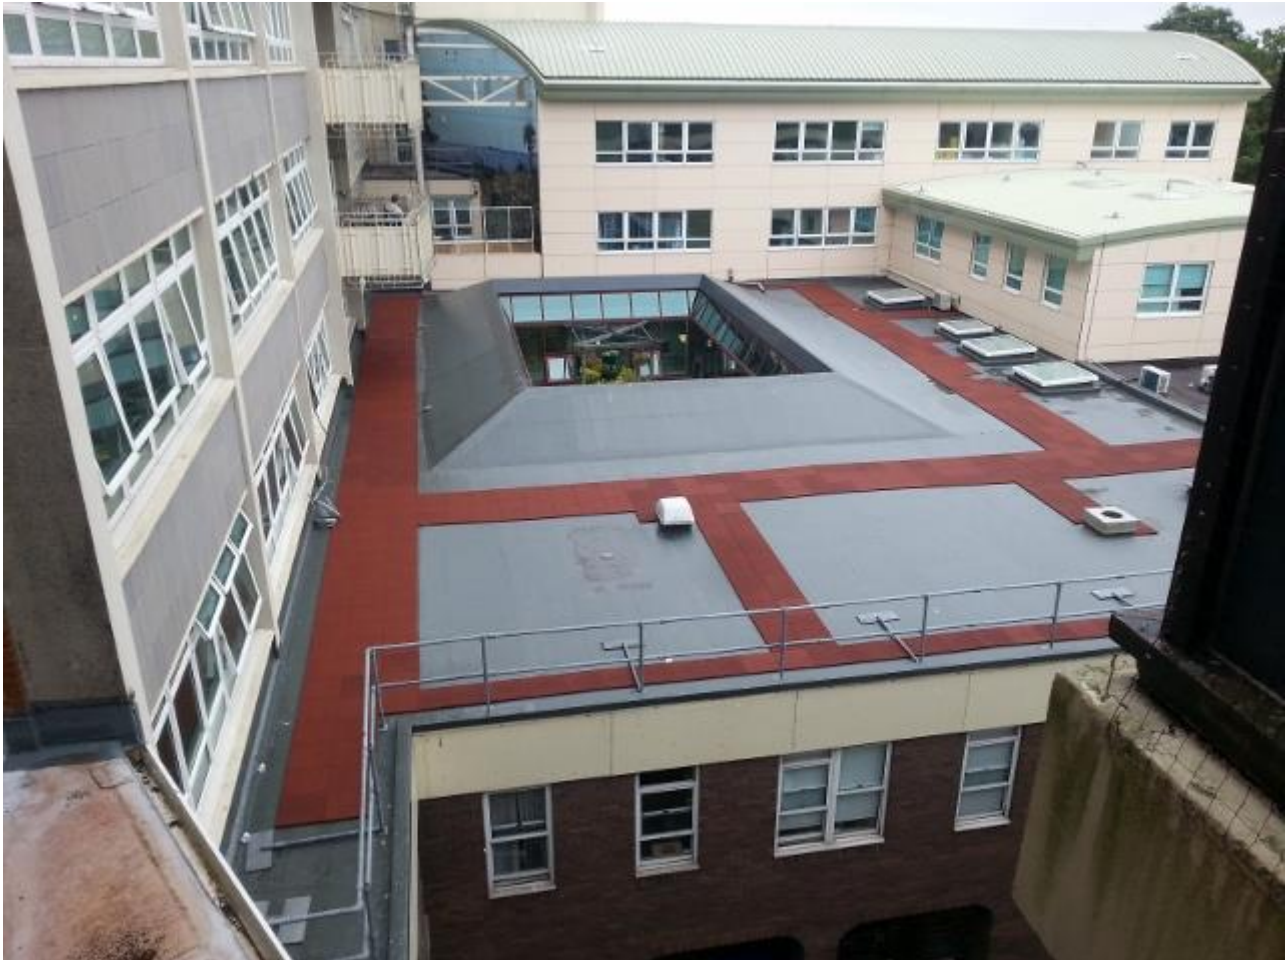
Kemper System's Kemperol 2K-PUR solvent-free and odourless waterproofing membrane has been used to refurbish the roof of Poole Hospital's outpatient department, ensuring that the project avoided any odours that could become a nuisance to staff and patients in the unit or the surrounding wards.

The cold-applied liquid membrane was installed by contractor, Hi Tec Roof Systems, overlaying the existing single ply membrane on the 480m<sup>2</sup> roof.

Hi Tec Roof Systems cleaned and prepared the roof, applying a fungicidal wash to completely remove any contaminants before applying a Kempertec primer. The Kemperol 2K-PUR resin was then applied in a single wet-on-wet process in which the resin is first applied to the substrate; reinforcement fleece is then laid directly on to the wet resin, immediately followed by more resin on top. This ensures complete saturation of the reinforcement fleece. Once cured the resin forms a seamless, elastomeric waterproof membrane that cannot delaminate, is UV stable, and bonds directly to the substrate.

Finally, a non-slip maintenance walkway was created on the completed membrane using tiles fabricated from recycled tyres.
