Refurbishment Scheme Makes a Splash in Cleethorpes

Cleethorpes, Lincolnshire

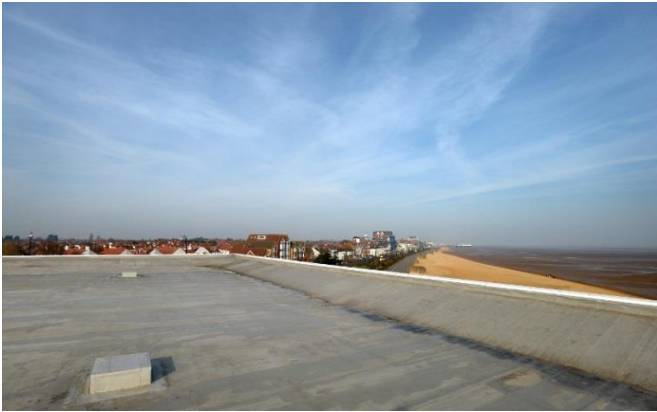
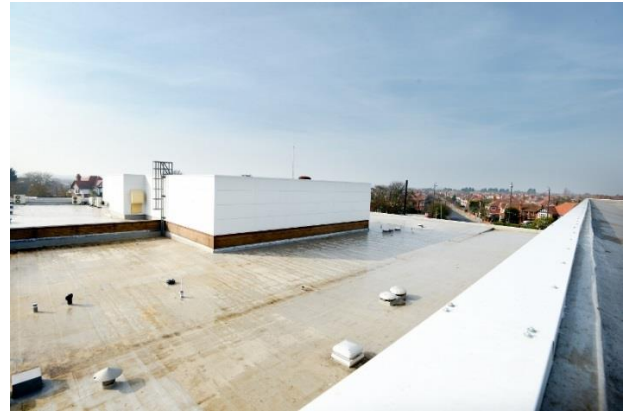
The roof was cleaned and prepared and the Kemperol V210 waterproofing system was then applied on top of the existing failed asphalt roof. Applied wet-on-wet in a single process, the Kemperol resin saturates a non-woven polyester reinforcement fleece and cures to form a seamless durable, UV stable, monolithic membrane that bonds directly to the substrate.

Jon continues: "The 5,000m² roof was a major area of concern because water ingress had already started to discolour some of the ceiling tiles in the pool area so it was affecting both the internal environment and showing evidence of failure. We needed a system that could be installed quickly without the need for a strip out of the existing roofing materials. The chosen system also had to be able to withstand the marine environment, strong winds and high levels of UV that the leisure centre is subject to in its coastal location: Kemper System's Kemperol V210 cold liquid-applied system was ideal."

Stuart Hicks from Kemper System explains: "The Kemperol V210 system has been designed to withstand even the harshest conditions. The direct bond created across the entire overlaid substrate when the resin cures greatly reduces the risk of wind uplift during stormy conditions, which is important for a coastal project like this."

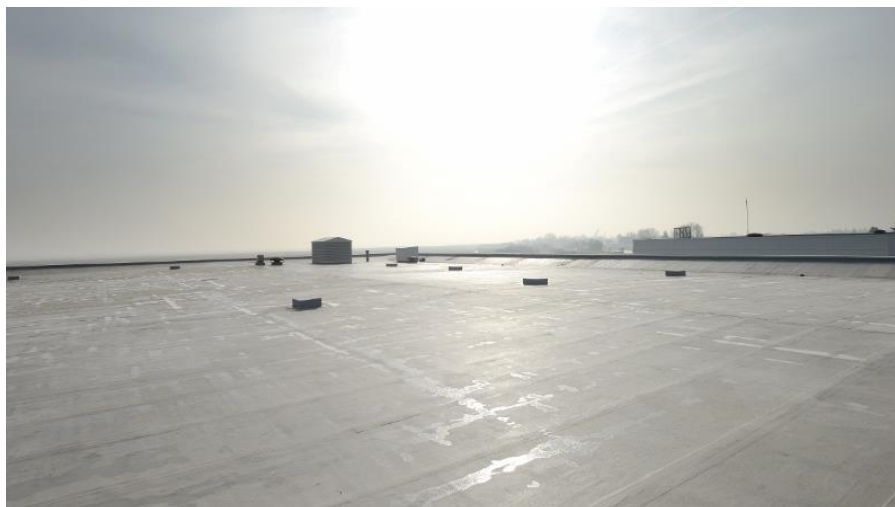
The leisure centre's external cladding was also replaced with a new, hardwearing system and feature lighting was introduced in the eaves of the roof to enable Lincs Inspire to light up the building in mood colours during the evening.
